Cromwell House, 100 High Street, Wheatley

Cromwell House analysis

Wheatley Village Archive, August 2021

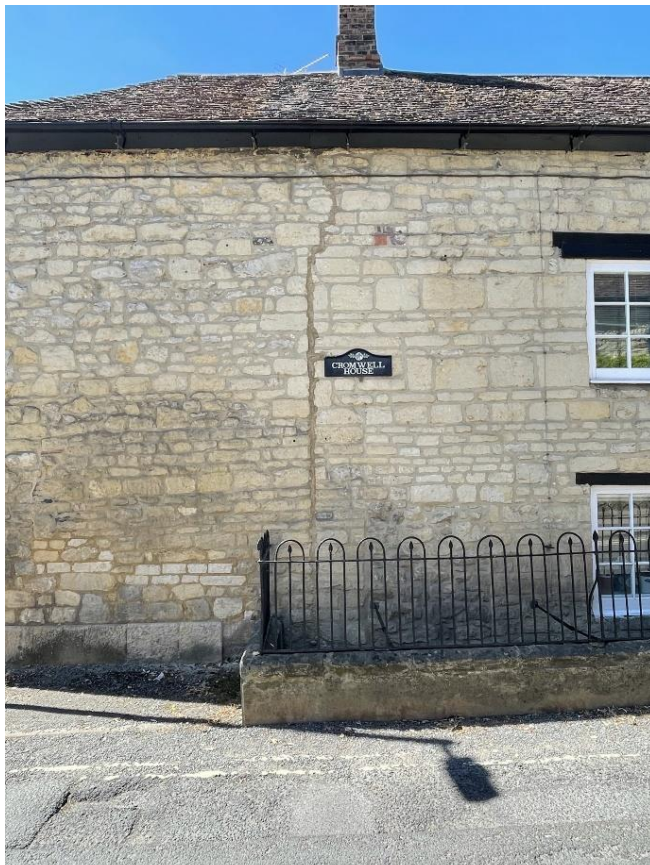
Figure 1

Cromwell House consists of two parts, the substantial part to the west (right in this picture) and a more modern part to the east, with the division very evident, as shown by the joint in the stonework left of the house name in Figure 1.

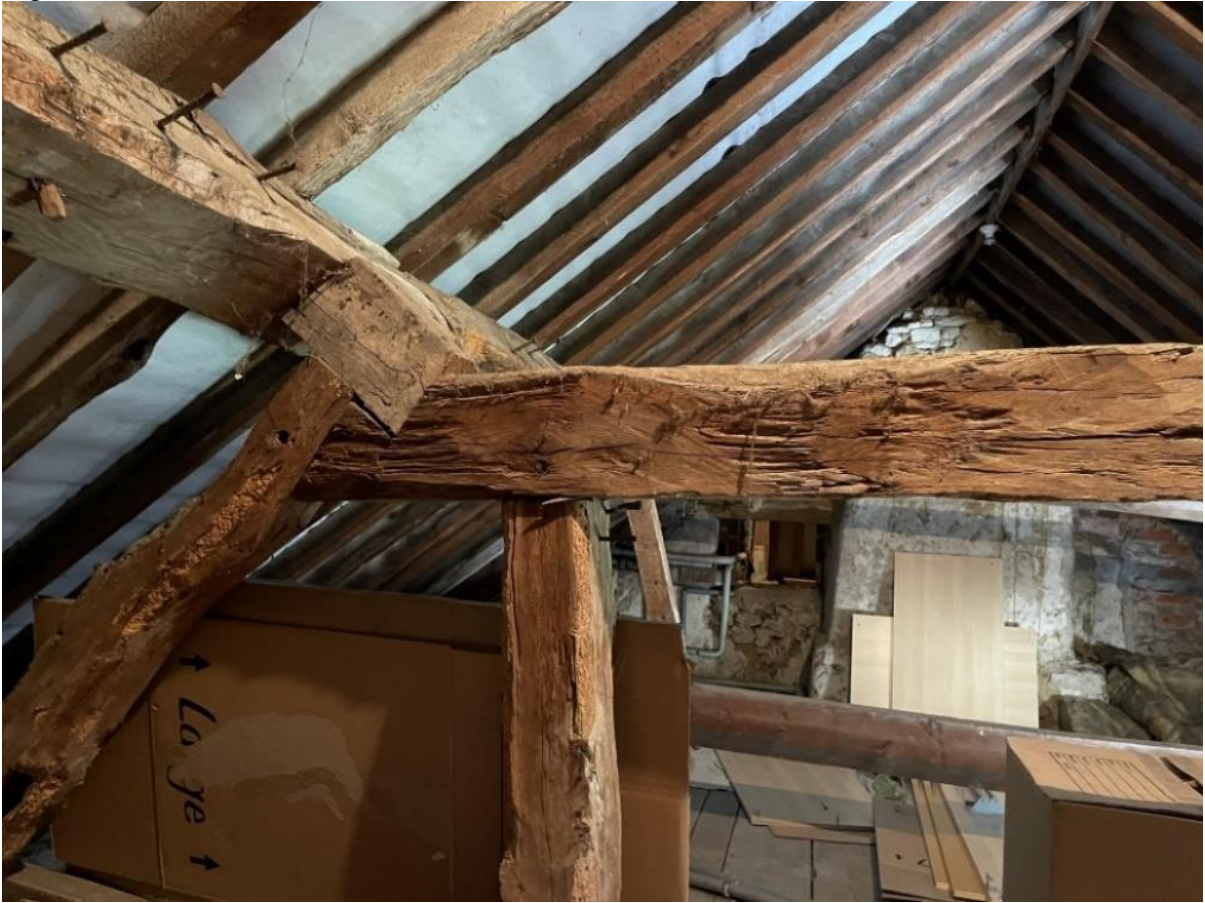
Figure 2

Some of the stonework is fine dressed, up to or beyond the standard of the other houses in the High Street, indicative of a wealthy builder/owner. The rather ragged stonework at the top; the evidence of an earlier steeper roof line (see the very different slope in the left corner of Figure 2) and brick ‘make-up’ at the rear (Figure 3) confirm that this house was originally thatched.

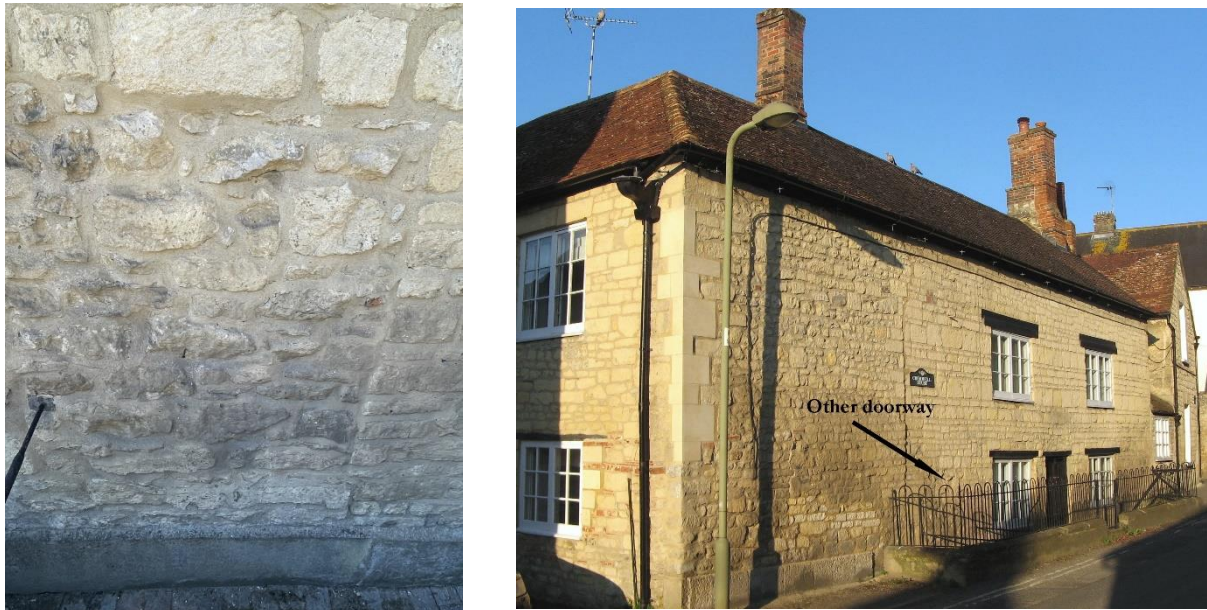
Figure 4

There was an earlier separate front door, although the presumed timber lintel has been removed, with the detail of the blocked-up opening and its position shown in Figure 4, this being suggestive that the house was originally two one-up one-down dwellings.¹

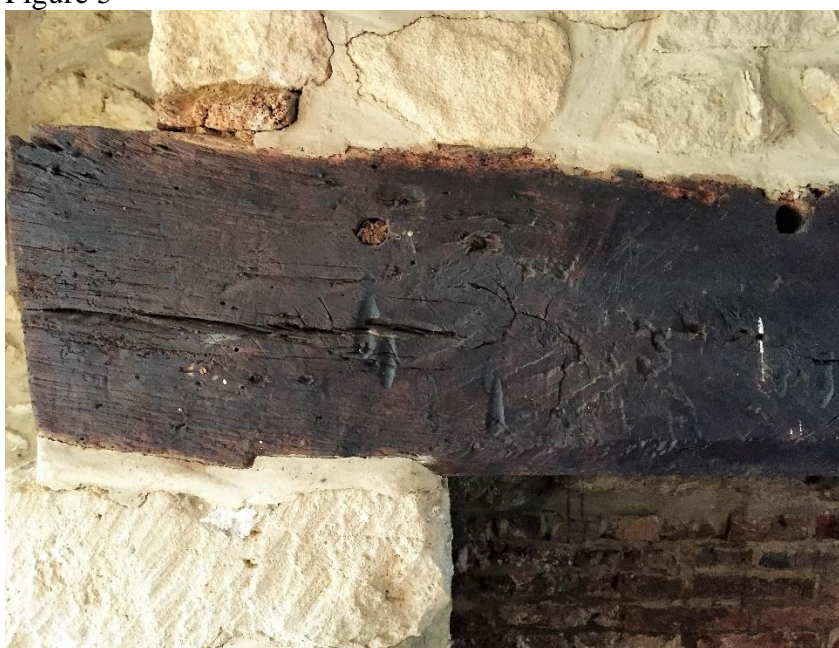
There are two fireplace beams in the house. The one at the west end is the more interesting as it appears to be older and has tell-tale marks on it. The timber here has split over the years as is normal for a timber of some age. This beam has a very large number of lozenge marks, associated with the warding-off of evil spirits in the early to mid-17th century. The two on the left in Figure 5 are very similar to ones in 6 Farm Close Lane, almost certainly a mid to late 17th century farmhouse. Most of the other marks are less precisely formed and may have been a later imitation detail. There is a chamfer on the front underside which does not extend to the full width of the hearth which suggests that this may have been re-cycled from an earlier use elsewhere.

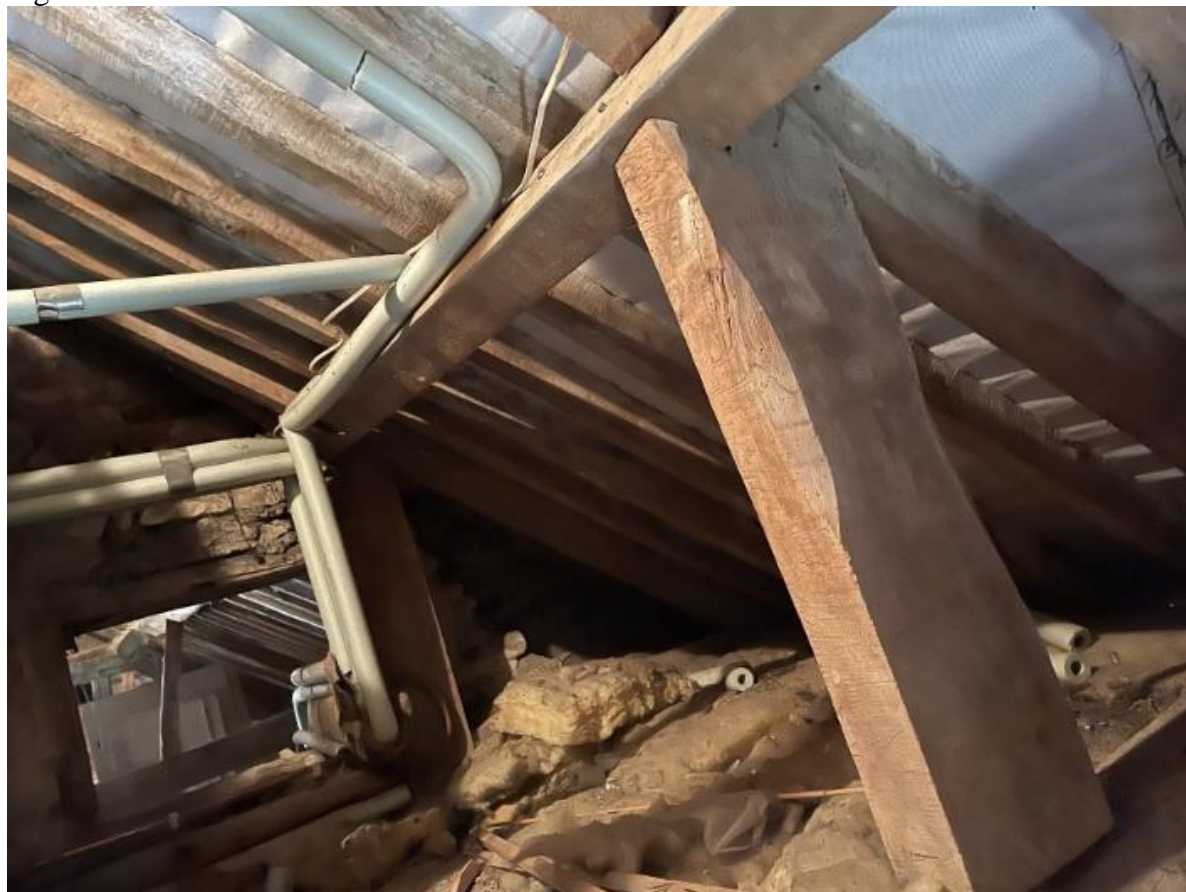
Figure 6

The east part of the house is a much newer addition as shown by the roof structure in Figure 6. Assuming that this has not been replaced, it has a presumed age of early 19th century. This part shows no evidence at the roof line of thatch, suggesting that the roof on the earlier building was converted from thatch to tiles at the same time as this extension was built.

The extension is not symmetrical being 3.85 metres at the front, 4.35 metres at the back and 4.05 metres at the (side) entry point.

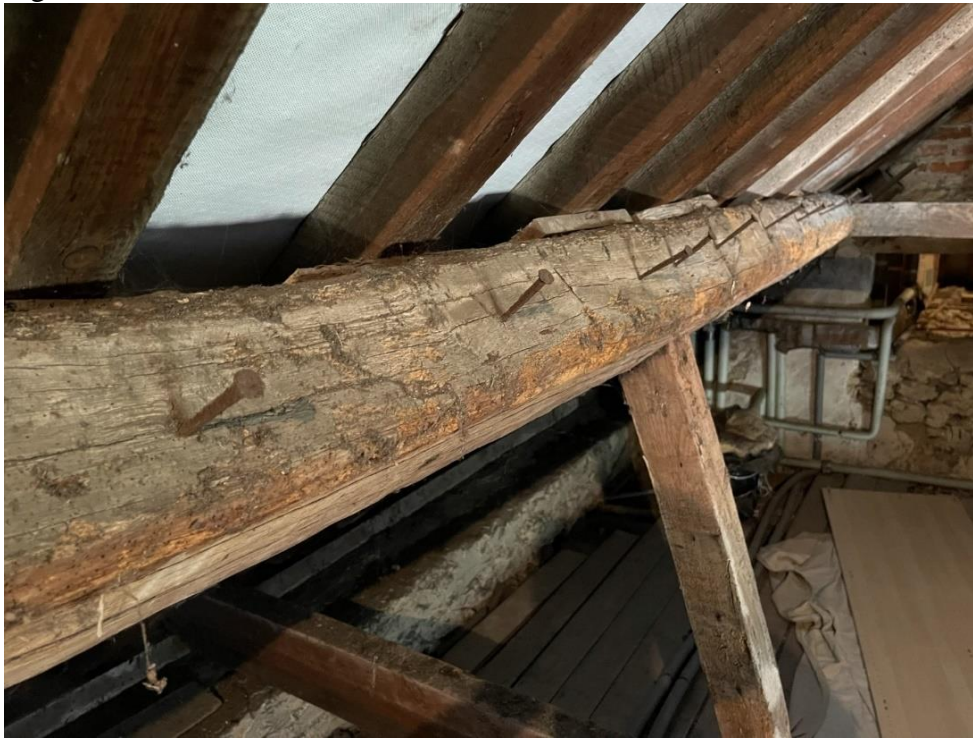
The upper part is alleged to have been used as a scarlet fever isolation hospital. Comments in the parish register reveal that there was scarlet fever in the village in 1863, and smallpox in 1865. The upper floor is also said to have been used in the tanning business for the drying of skins, and later to have been used by a tailor. The nails in Figure 8 might have something to do with the hanging of hides (when it was the premises of a fellmonger) or a tailor's business?

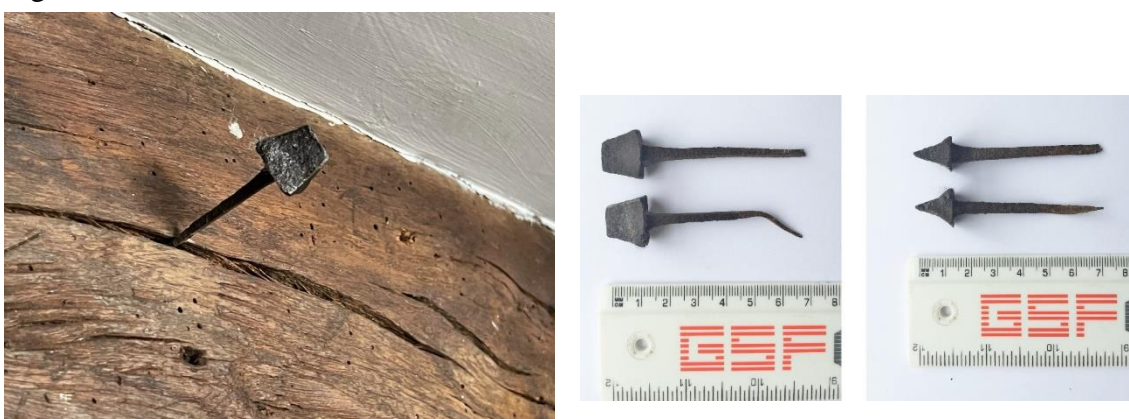
Figure 9

Other nails, about 7cm (2.75") long and shown in Figure 9, found in the house are frost nails for securing horseshoes onto hooves in icy conditions, this trade then being carried out by the blacksmith who had his business here in the early 1900s.
