OXFORDSHIRE BUILDINGS RECORD REPORT OBR.392

**Ambrose Farm
55 Crown Road
Wheatley
OX33 1UL**

Introduction

The objectives of the survey were to understand the dates and phases of the building.

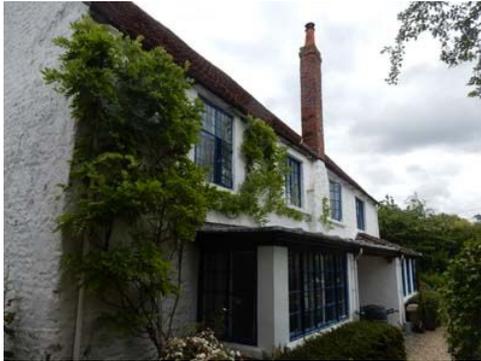
Figure 1 Ambrose Farm, south elevation

There are two wide single-storey extensions to the south façade (Fig.1), effectively bay windows, with metal window-frames. The eastern is hipped with a tile covering; the western has a flat roof that extends over the gap between, forming a porch over the front door. Also to this façade is a lateral stone chimneystack, extended upwards above eaves height in brick. It has one chimneypot. There are four large windows at first floor level in the south elevation. All have metal frames, but that to the west is a cross-window with leaded lights and a late 17th-century style of turnbuckle catch (Fig.7).² The others are early 20th-century casements.

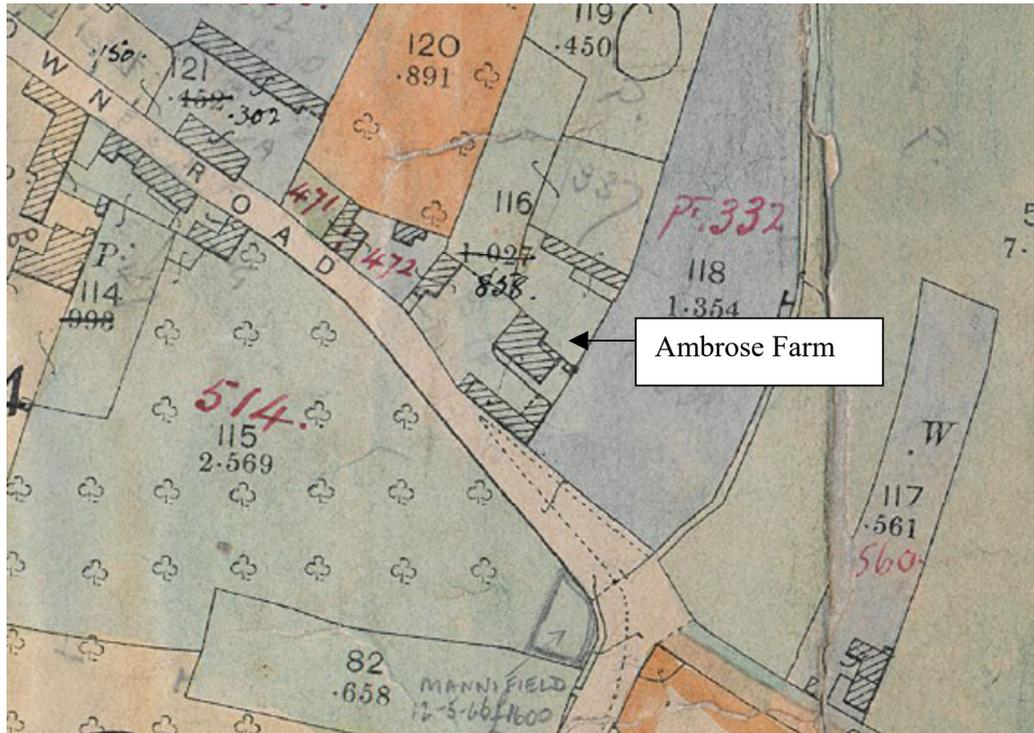
Ambrose Farm was plot 337 on the 1910 District Valuation map (Fig.2). It lies on the north side of Crown Road, an early main road through the village. At the time of the

Figure 2 Extract from 1910 DV map (Reproduced by courtesy of the Oxford County Council – the Oxfordshire History Centre)¹

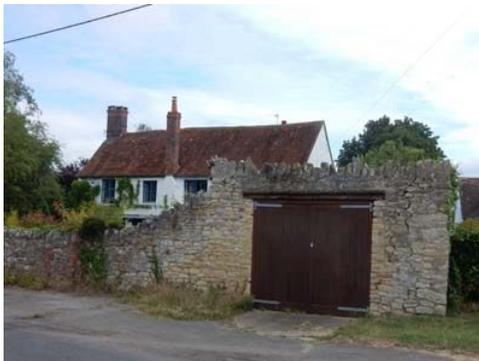
Figure 3 Street elevation

DV map, there were agricultural buildings between the house and the road. Some parts of these may survive in the street wall (Fig.3).

At the apex of the western gable is a brick chimneystack in two parts, though now of similar brickwork with a flat ‘table-top’ cap and a total of three flues (Fig.3).⁵ To the rear is a further brick stack with one flue at the gable of the western wing, and another in modern brickwork with two flues within the lateral wall at the east of the front range (Fig.4).

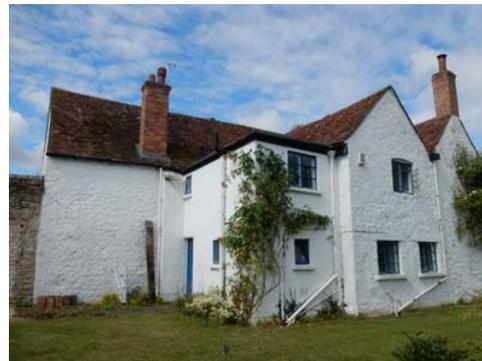
Figure 4 North elevation

Ambrose Farm consists of a rectangular range running east-west, with two gabled wings to the rear (north) and a modern two-storey extension in the angle between the earlier elements (Fig.4). The main building material is limestone rubble, uncoursed and whitewashed. There are dressed quoins to the north-east corner of the front range. The roof covering is plain red tile.

- b. The rear wall of the front range is blank in the far eastern bay (left in Fig.4)
- c. There is evidence of a relieving arch in the stonework above the ground floor westernmost window (right in Fig.4).
- d. There is a round stone feature at ground level at the south-east corner.
- e. The north-western corner of the wing is chamfered.

The eastern rear wing has two square-headed casement to the ground floor and a first floor window with a brick segmental head (Fig.4). This window has a casement with a spring catch (Fig.11) – a type which, according to Hall, became very popular in the south-east in the 18th-century – also the likely period of the segmental head.⁴

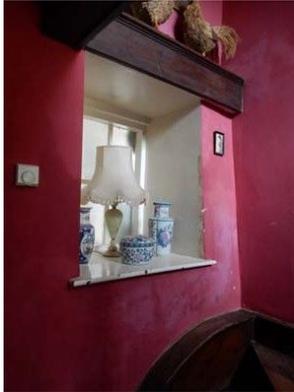
Figure 5 Front range rear wall

- a. Some of the walls have a distinct ‘batter’ – that is, they taper towards the top. This can be seen in the rear wall of the front range (Fig.5) and in the wall of the westernmost rear wing (Fig.6).

The fireplace of the southern lateral stack can be seen in G2. It has a brick head and is sufficiently narrow to have held a Victorian coal-burning grate. A modern staircase leads from G2 to the first floor. It is lit from the north by the internal window shown in Fig.5.

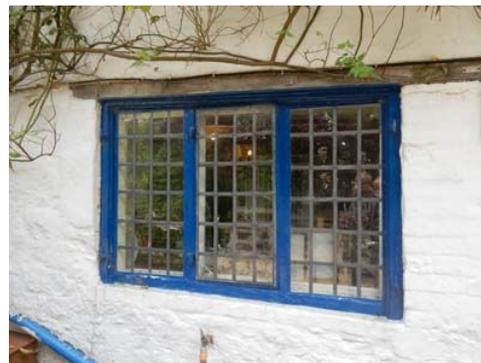
Figure 8 West window of rear wing

There is another early window in the west wall of the rear wing (Fig.8). This has three lights, leaded, with the central a hinged casement. There are pintles for shutters to

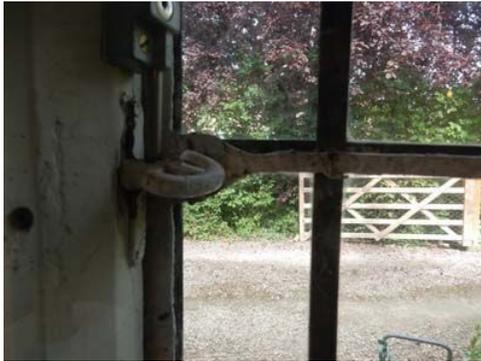
Figure 9 Turnbuckle catch

either side. The catch (Fig.9) is of a late 17th-century design and the twisted hook stay (Fig.10) is of the same period.³

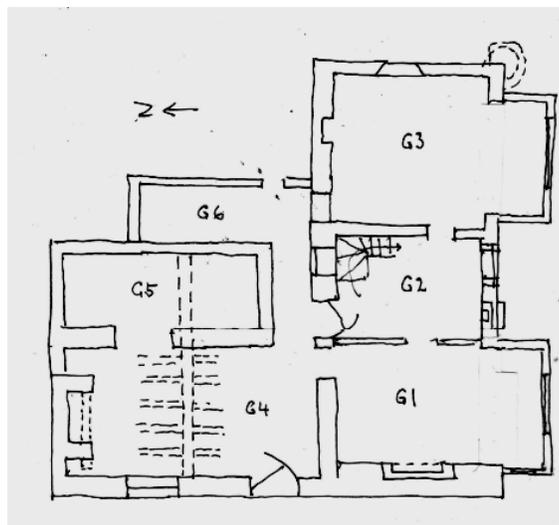
Figure 12 Ground floor plan (not to scale)

The ground floor plan is sketched at Fig.12. G1 has been considerably remodelled in the 20th century, but its main feature is the stone fire surround at the west gable (Fig.13). This has a Tudor-style four-centred arch with recessed spandrels and moulded jambs with chamfers that stop well above floor level. These high stops are

There are no early features in G3. In G4 and G5, however, a heavy beam (Fig.14) spans both spaces and is cantilevered over a thick stone wall between them as shown in Figs.12 and 14. Where it enters G4, two sections are joined by a scarf joint that has a single peg for a secret bridle, and the squinted abutment ensues a degree of stability. The joists in G4 are lodged over this beam, rather than being tenoned into it, but there are two pegs visible in the soffit, one of which has a section of tenon still adhering (Fig.15).

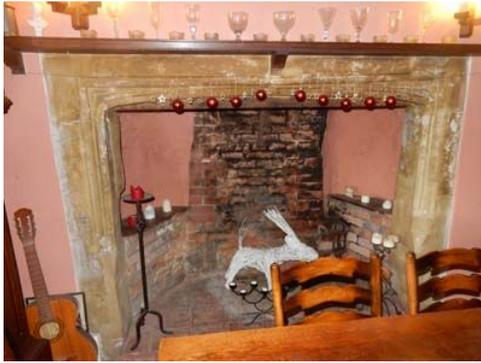
Figure 13 Fire surround in G1

often associated with 16th century fireplaces, but Hall illustrates a mid-17th-century example from Wiltshire.⁶

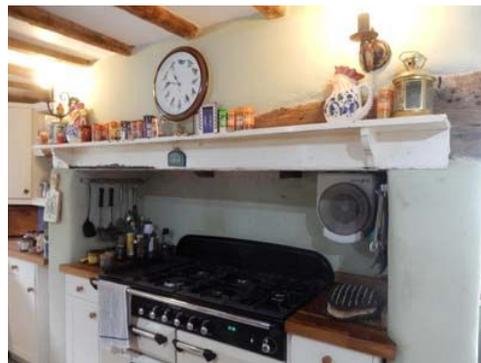
Figure 16 Fireplace in G4

The other major feature of G4 is a wide fireplace (Fig.16) spanned by a deep bressumer that extends beyond the present western jamb and has been rather crudely cut back there. The only marking visible on the bressumer is what appears to be a level mark (Fig.17) – easily mistaken in this context for an apotropaic symbol.⁷

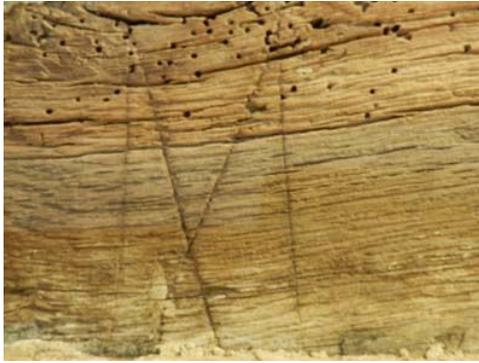
Figure 17 Level mark on G4 fireplace bressumer

⁷ Level marks are lightly scored cross-like marks, which were used to obtain two parallel flat faces when hewing a log. (See, D W H Miles and Henry Russell, 'Plumb and Level Marks' in *Vernacular Architecture* 26 (1995) pp.33-38.)

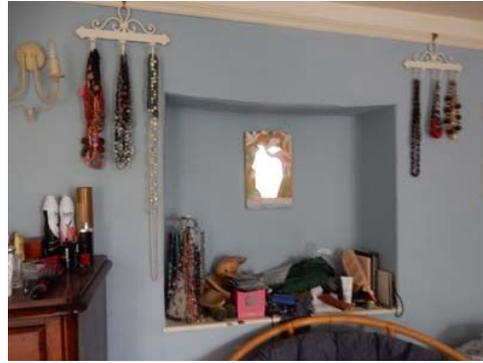
Figure 18 Former window in F1

The first floor spaces are indicated as F1-F6, the rooms above G1-G6 respectively. The window in F1 has already been noted (Fig.7). At the opposite (north) wall is a blocked window (Fig.18). The fireplace in F1 is blocked in. [is this right?]

As for the wings to the north, the fact that the ground floor walls do not correspond to the present gabled structures above suggests that the latter were created as a result of a later rebuilding – perhaps in the 1720s, when segmental arches were in fashion. The evidence of the roof structures in the attic suggests that these gables were built at about the same time, and after the roof of the main range. There is, however, a major question about the ground floor space represented by G4 and G5 – is this contemporary with, or even earlier, than the main range? One possibility, for example, is that G4/G5 was a detached kitchen – the blocked window in F1 suggests that G4/G5 was either single-storey or did not abut the main range.

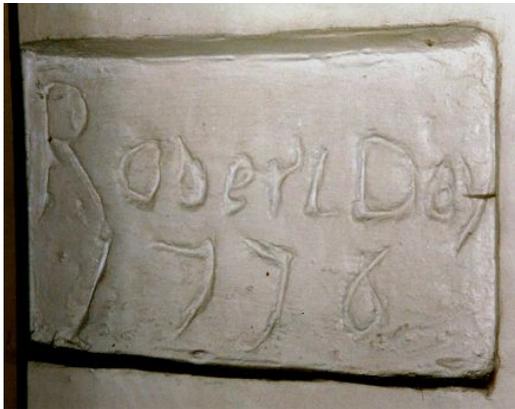
Figure 19 Robert Day datestone

A significant feature in G4 is a date-stone inscribed, 'Robert Day 1776' (Fig.19). This is set into the wall between G4 and G1.

Finally, there is the matter of the 1776 date-stone. If the above analysis is correct, this cannot be taken as indicating when the front range was built. So does it represent a later building phase, or simply a change of ownership? It could relate to the reconstruction of G4/G5 and the pair of gables, but it is an odd place to put such a commemoration – most are prominently displayed on an external elevation.

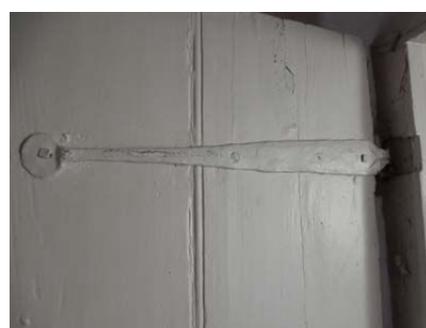
Figure 22 Strap hinge

iron latch with a Suffolk handle (Fig.21) nailed to the door, but on the 'inside' – ie within F4. The only fitting that can be closed from within F4 is a modern bolt latch. The door itself is formed of three vertical planks, held together by four battens at the back. It has two strap hinges (Fig.22) supported by pintles fixed to the frame. The ends of these hinges wrap round the door at the pintles are on the 'outside'. Almost everything about this door speaks of it being an entry from F4 into a private room in the position of F5. But one of the oddities is that - whether it opens to F4 or to F5 – it does so in the 'wrong' way, as the normal way a door is hung in England is on the other jamb, so that the door opens into the room, not against the wall. Whatever the reasons for this, it should be noted that the hinges and latches are all nailed in place, and so likely to be in situ.

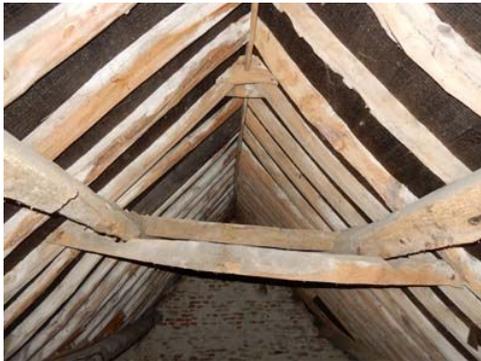
Figure 23 Roof above G2 and G3 looking east

Fig.23 shows the roof above G2 and G3, looking east towards the stone gable wall. There are two tiers of purlins supporting common rafters, though in the foreground, a plank collar with notches near each end has been nailed across one pair of rafters to form a makeshift truss, intended to clasp the purlins to the rafters, though these have now parted company. Also at the apex of this 'truss' is a pair of saddles supporting a plank ridge that runs along the length of this part of the roof. Fig.24 shows part of the upper purlin to the south, with augured stave mortices at regular intervals along its length. These make no sense in its present context, and adds to the evidence that this part of the roof has been rebuilt at some stage.

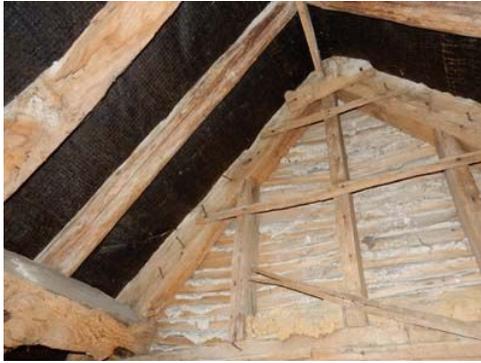
Figure 25 Truss above G1/G2 partition

Above the partition wall between G1 and G2 is a fully carpentered roof truss (Fig.25) This is an A-frame, with assembly marks at most of the joints, such as that between the collar and the principal rafter at the north (Fig.26).

The truss is 'closed' by means of a framework of studs (Figs.25 and 27) which are tenoned into the collar and tie-beam below. Each stud has a chiselled assembly mark (Figs.28 and 29) and these run in order from north to south. To this framework of studs are nailed riven oak laths which support the plaster wall-covering of the space behind to the west. There are also some laths nailed to the eastern face of the truss (Figs.25 and 27), but this work was never completed, as there is no sign of plasterwork on this side of the truss.

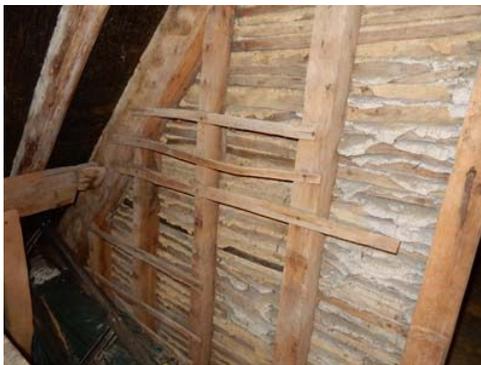
Figure 27 Lower section of Fig.25 partition

Fig.36 shows the corresponding north purlin joint, which has been strengthened using iron bolts – and presumably a plate behind. The loose tenon for the lower purlin can be seen in Fig.27 above where it emerges from the partition truss, but does not connect with the present purlin in the eastern bay.

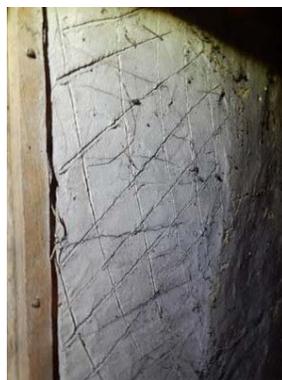
Figure 30 Wall plaster

The west face of this plasterwork is shown in Fig. 30. It has a pattern of diagonal scratches suggesting that it was intended to add a further coat.

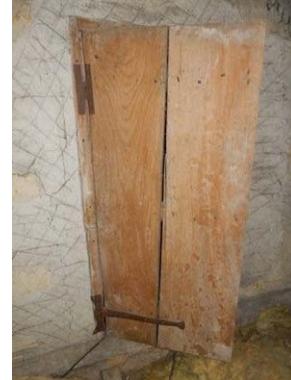
Figure 31 Attic door

In the centre of the partition is a door (Fig.31) opening into the western space. Made of two planks secured by three battens, the upper hinge has a plain H shape, while the

lower is a cross-garnet with an unusual decorated fixing plate. Both are nailed in place.

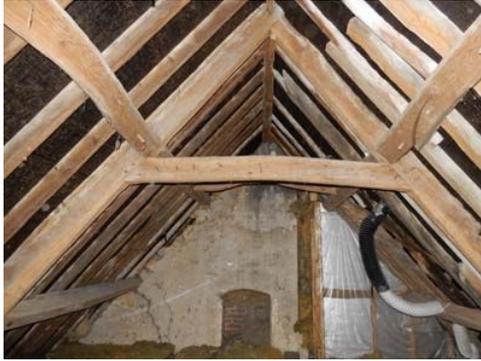
Figure 32 Western attic room

The space beyond the partition truss is a two-bay room (Fig.32) with a fireplace in the west gable wall and another A-frame roof truss at its centre. This truss has fine details such as a stop-chamfered collar and principal rafters (Fig.33).

It is, however, clear that the western attic room was intended from the start, as the partition studs could not have been introduced after the truss was in place. The fireplace does, though, seem to be a later insertion, but the room does not seem to have been used, as the fireplace is clean and the plasterwork incomplete.

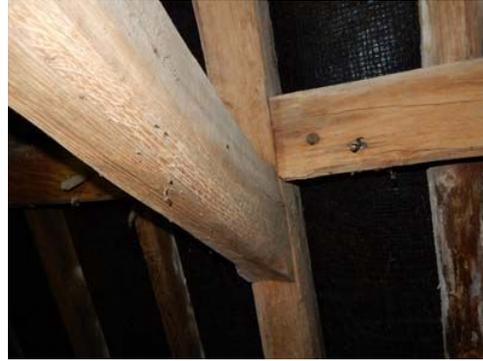
Figure 33 Detail of roof truss

The purlins are supported by the stone gable wall, and are butted to the truss above the collar, where they are secured by a loose tenon passing through the rafter and pegged to each section of purlin with a pair of wooden pegs (Fig.33). The tenon itself can be seen in Fig.34 at the soffit of the purlin just above the chiselled I assembly marks on collar and principal.

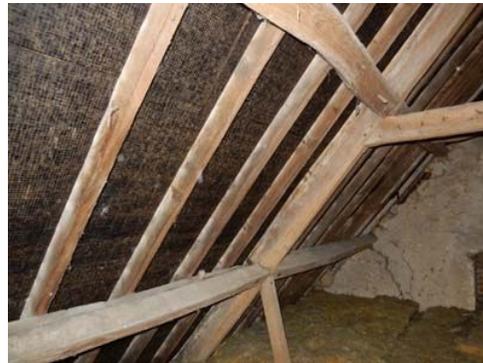
Figure 35 South roof slope

The lower tier of purlins are also fixed in the same way (Fig.35), but structural issues have necessitated the introduction of short raking struts to support the joint.

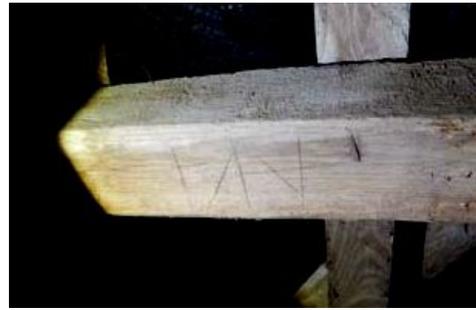
Figure 37 Level mark on north purlin

There is a level mark on the face of the north purlin (Fig.37) – a different design from that on the kitchen bressumer.

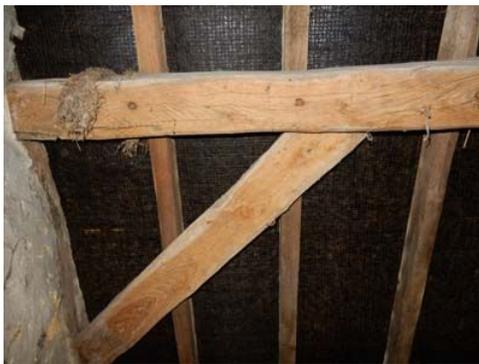
Figure 38 Windbrace at partition truss

There is a straight wind-brace between the upper purlin and the partition truss (Fig.38). This illustration also shows the pegs that fix the rafters to the purlins, but also that some of the purlins have been renewed, and indeed only a few extend down the whole of the roof slope. The replacement of rafters has required a plank ridge to be inserted to support the tops of those that can reach it. Fig.39 shows the north roof slope, where there are also many replacement rafters.

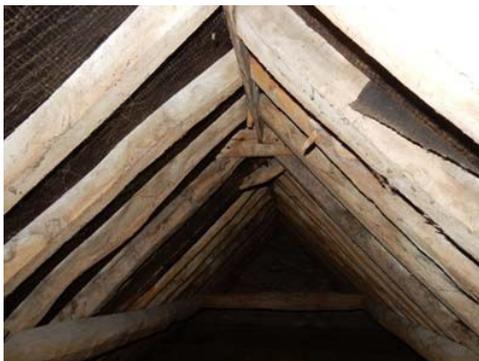
Figure 40 Eastern wing roof

The roofs of the gabled north wings can be seen from within this attic space. The roof of the easternmost wing is shown in Fig.40. This is a common-rafter roof with no

intermediate truss, the rafters being supported by long purlins, separated in the centre by a birdsmouth collar. The purlins are simply lodged over those of the front range of the house (Fig.41), so the wing roof has no independent structural stability, suggesting that it was built on to a pre-existing structure. This is confirmed by the fact that all the

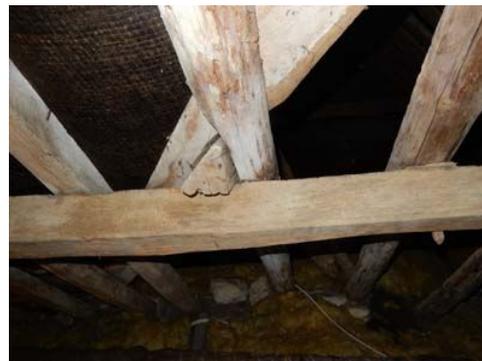
Figure 41 Purlin of wing resting on main roof

rafters of the front range are present and intact. There is a plank ridge (which may be secondary).

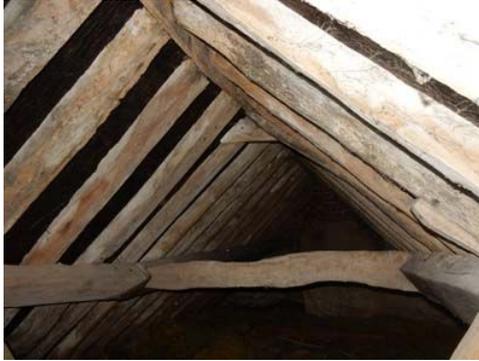
Figure 42 Western wing roof

The western north wing roof can also be seen (Fig.42). Its construction is similar to that of the other wing. The main difference, however, is that there has been a greater disturbance in the main range rafters at the junction of the two roofs. In particular, one of the replacement rafters (Fig.43) has an empty mortice and appears to be sooted, so possibly reused from a medieval context somewhere.

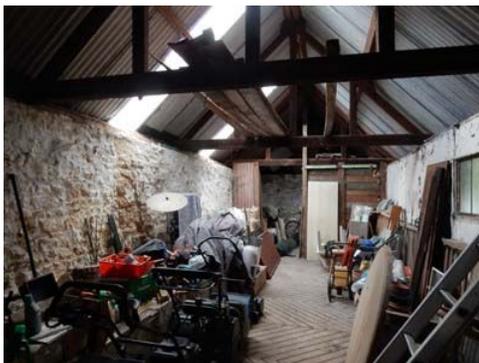
Annex 1 Fig. 1 Shed interior

The roof structure is modern, as is the concrete floor with drainage channels (Fig.1). Along the rear wall is a concrete plinth into which are set short timber posts at regular intervals (Fig.2). Each has an iron tethering ring about 12 inches from the base.

Heather Horner, OBR's specialist on agricultural buildings, adds that 'The long shed at Ambrose farm has probably been used as a (hand) milking parlour – the animals tethered temporarily with a clip-on neck chain, with their heads in a bucket of feed to keep them quiet while the dairymaid worked at the other end.'
