## OXFORDSHIRE BUILDINGS RECORD REPORT OBR.360

**Gardencroft  
5 Roman Road  
Wheatley  
OX33 1UU**

The objectives of the survey were to understand the dates and phases of the building.

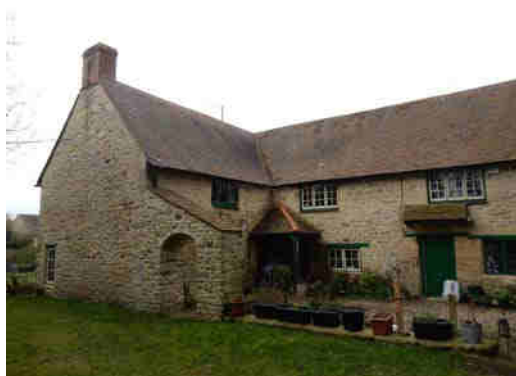
**Figure 1 Gardencroft**

Fig.1 shows the house from the south-west. The west wing forms an L shape with the main range. The building material is limestone, probably mostly the local corallian ragstone, with some larger dressed stones, particularly for the south-west quoins. In the west gable of the wing the line of a lower roof slope can be discerned – the earlier stonework is smaller and has a greater rubble content. The roof is covered with plain red tile. In the west elevation (Fig.1) are two doorways to the main range, that to the south with a tiled pentice hood; a tiled porch shelters the northern door and a adjacent one to the west wing.

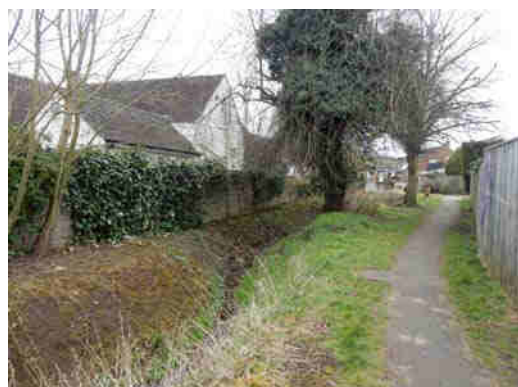
**Figure 3 Stream to west of plot**

lies within a larger open field, bounded on the west by a stream (Fig.3). This belonged to Ambrose Farm,

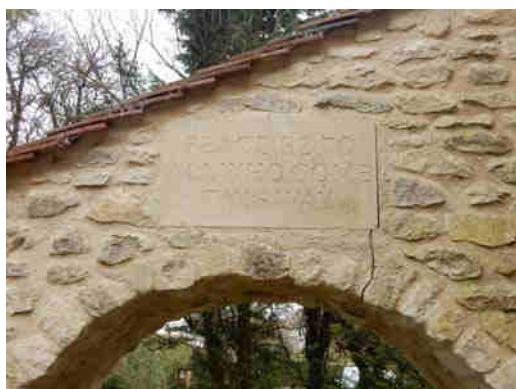
**Figure 4 Inscribed plaque**

The stone archway/buttness seems modern and has an inscribed plaque ('Peace be to all who come this way') on the east side (Fig.4).

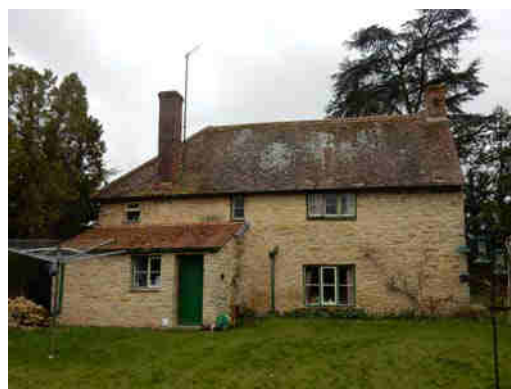
**Figure 5 North elevation**

The north elevation is shown in Fig.5. This shows the pitched roof over the main range where it joins that of the wing. There is a modern stone lean-to outshut against the end of the main range, with the remains of an earlier structure embedded in the wall to the west. The roof is plain red tile. There is a brick chimneystack at the west gable of the wing, and a tall brick stack rising from the roof-slope at the northern end of the main range. The windows are casements throughout; to the ground floor at this elevation the tripartite window has a stone lintel.

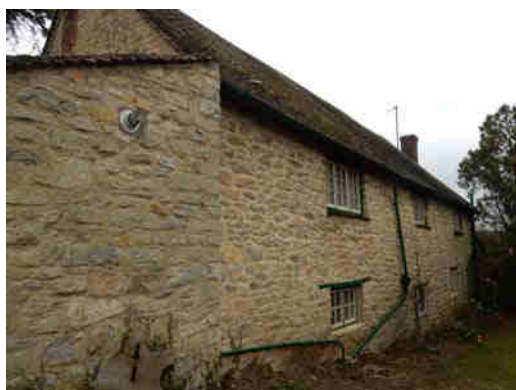
**Figure 6 East elevation**

The east elevation is shown in Fig.6. To the south is a further lean-to outshut, of stone, with a weatherboarded west wall. The main range has three windows to each floor, all slightly different. The ground floor has a modern casement under a long timber lintel to the south (Fig.7) another in the centre (Fig.8) and an older one to the north (Fig.9). Each of these is at a different height. The first floor windows are all at

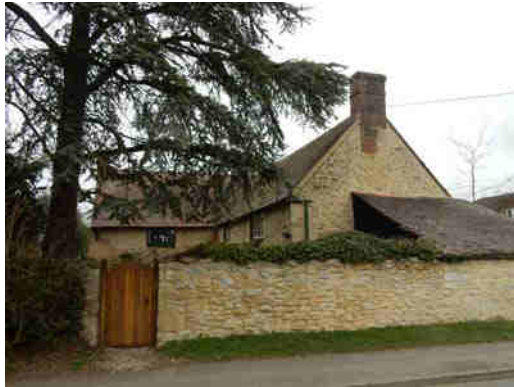
**Figure 10 South (street) elevation**

the same level and are tripartite casements. There is a brick stack at the centre of the south gable wall (Fig.10).

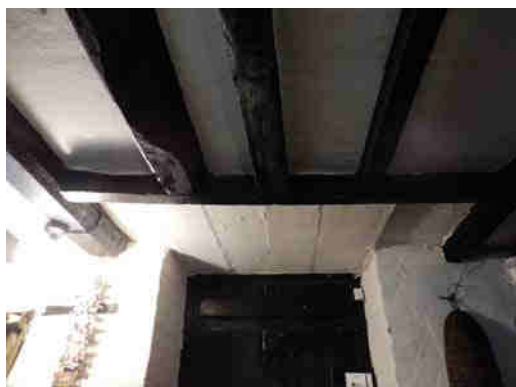
**Figure 14 Joist arrangement at front door**

The lintel of the doorway is above the height of the joists, so those near it terminate at a trimmer (Fig.14) and the joist pattern in this area is somewhat irregular. This suggests that the doorway was inserted after the room was floored in.

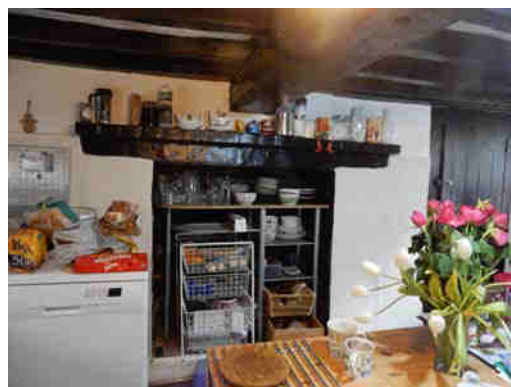
**Figure 15 Fireplace in G1**

There is a timber stud partition wall to the south of G2 through which a doorway gives access to G1 (Fig.15). The west wall of G1 is not as thick as in G2. G1 also has a deep, chamfered spine beam, but the joists are mostly square in section and are lodged over the lintel of the exterior doorway in the west wall. To the south is a (blocked) fireplace with a timber lintel.

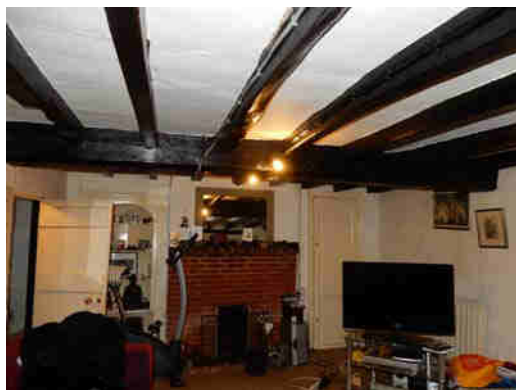
**Figure 16 G3 looking north**

To the north of G2 is a further timber partition, with a doorway to G3 (Fig.16). The wall thicknesses here are considerably less than in G1 and G2, and the ceiling beam is set transversely across the space. This has a good quality chamfer and delicate stop (Fig.17). The ceiling joists are square, chamfered and to the south are lodged over the partition to G2. At the north wall is a further chimneystack with a modern brick fireplace. To either side are cupboards, one open with an elliptical arched head, the other with a panelled door.

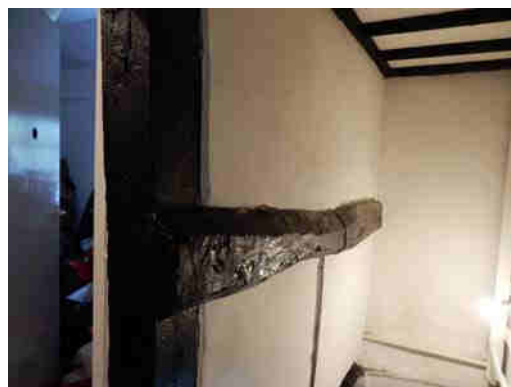
Along this wall is a thick beam (Fig.19) that has been truncated at the landing to allow access to F1. As shown on the plan, F1 is now divided by a thin partition – which intersects the chimneystack – into two rooms. In the western room, part of a timber roof truss is visible (Fig.20). The horizontal timber is the rear of that in Fig.19, and seems to be a tie-beam, which supports a queen-strut, above which is a collar with an angled end, presumably where it was pegged in to the principal rafter.

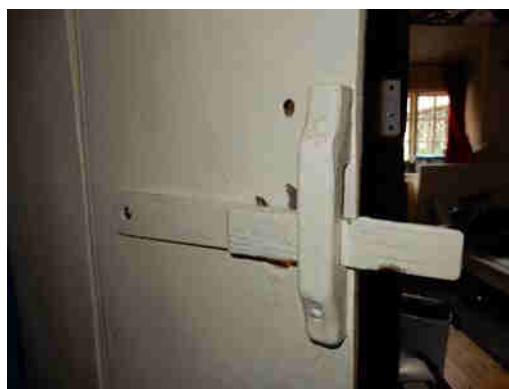
**Figure 21 Door latch to F1**

As elsewhere in the house, the door to F1 is formed of vertical planks joined by timber battens, and has wooden door furniture (Fig.21), mostly in situ. The hinges are mostly hand-wrought blacksmith work, but most are screwed in place, and so even if of an early date, may have been moved or altered.

2. In particular, the staircases must date from this roof-raising, since otherwise the attic spaces would have been unusable. The doors and their wooden latches, could date from the early 17<sup>th</sup> century.<sup>6</sup> Indeed, the ceiling beams and joists visible on the ground floor could all be contemporary.

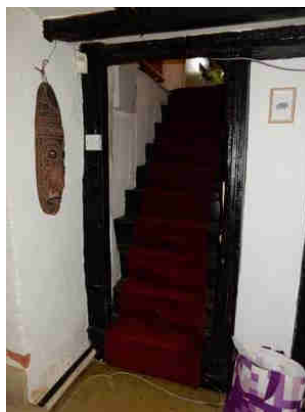
**Figure 23 Staircase to F3 and F4**

Returning to G2, a straight flight of stairs (Fig.23) within a boxed-in section of G3 leads to F3 and F4. F3 has also been partitioned into two rooms, the upper part of the G3 chimneystack being visible at the north end.

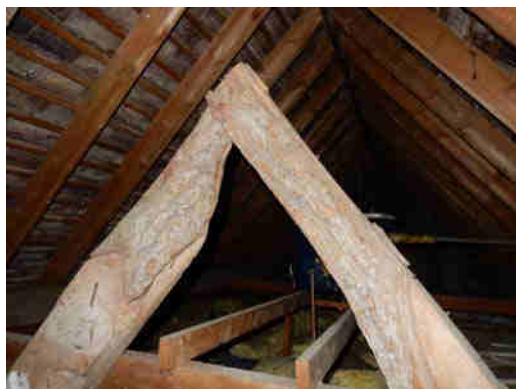
**Figure 26 Eastern roof truss of west wing**

The roof, often indicative of the earliest phases of the history of a house, was almost entirely modern. The timbers were softwood of thin scantling, with only one truss (Fig.26) surviving from an earlier phase. This comprised a pair of elm principal rafters, with a considerable amount of bark and pegged at the apex. The western face was smooth, but had no distinguishing features such as assembly marks.
